Case Study: Treatment of PFAS contaminated landfill leachate using Surface Active Foam Fractionation (SAFF)

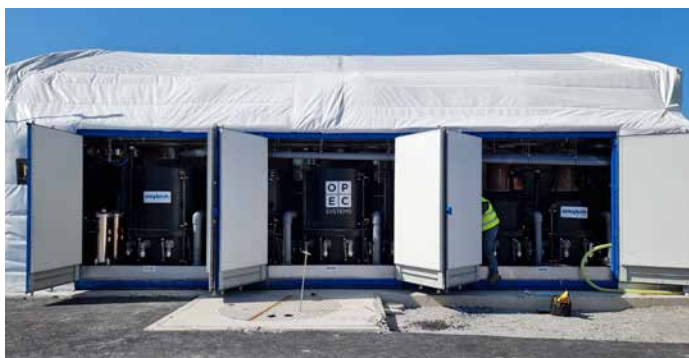
Figure 1: Full scale SAFF40 treatment system installed at Tveta Landfill

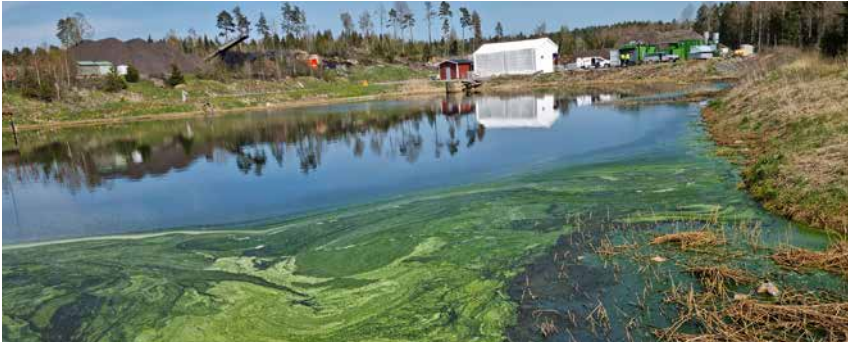
Figure 2: Photos of the leachate pond in summer and the algae blooming that occurs. The SAFF40 treatment plant is situated in the white tent at the far end.

The leachate water contains a mixture of co-contaminants, as well as as nitrogen, phosphorus DOC, TOC, suspended solids and more, in accordance with table 1. In summer, the pond also “produces” large amounts of larva and zooflagelats, as well as algae. This combined has led to all of the previous treatment trials performed with various filter technologies have failed.
